# Management of Corrugated Steel Buried Structures

**AM-STR-06019**

June 2014

**NRA BA 87/14**

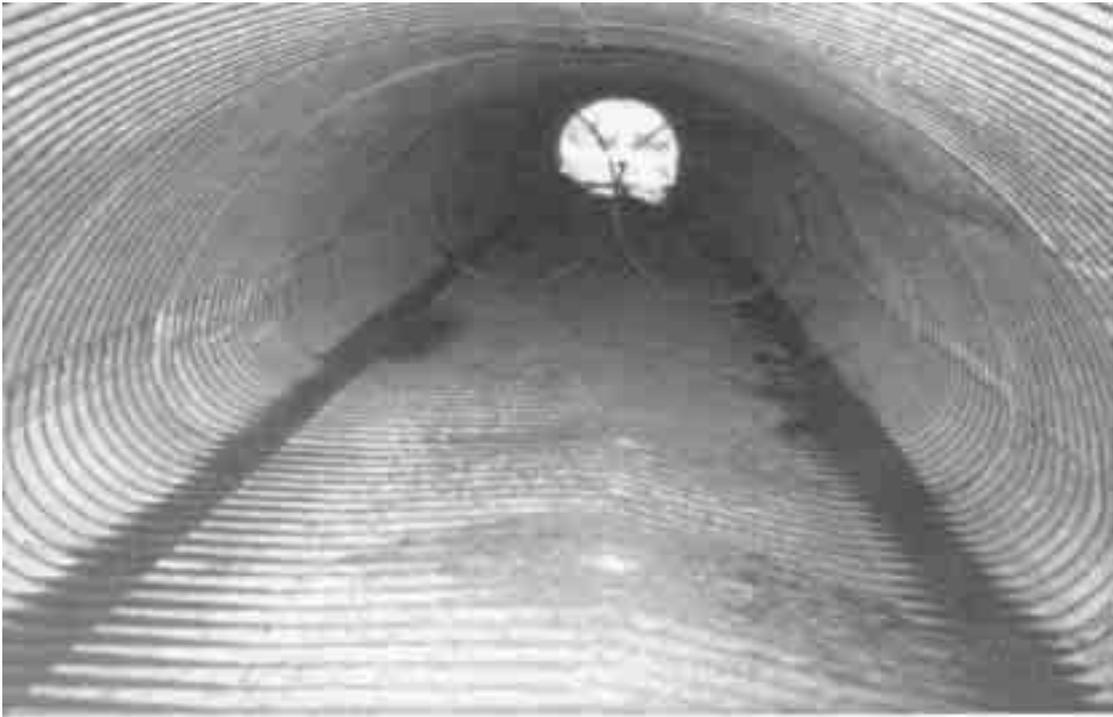
**Figure 5.1a** Reverse curvature in the invert of a multi-plate pipe-arch caused by settlement of the surrounding embankment (from SETRA, 1992)

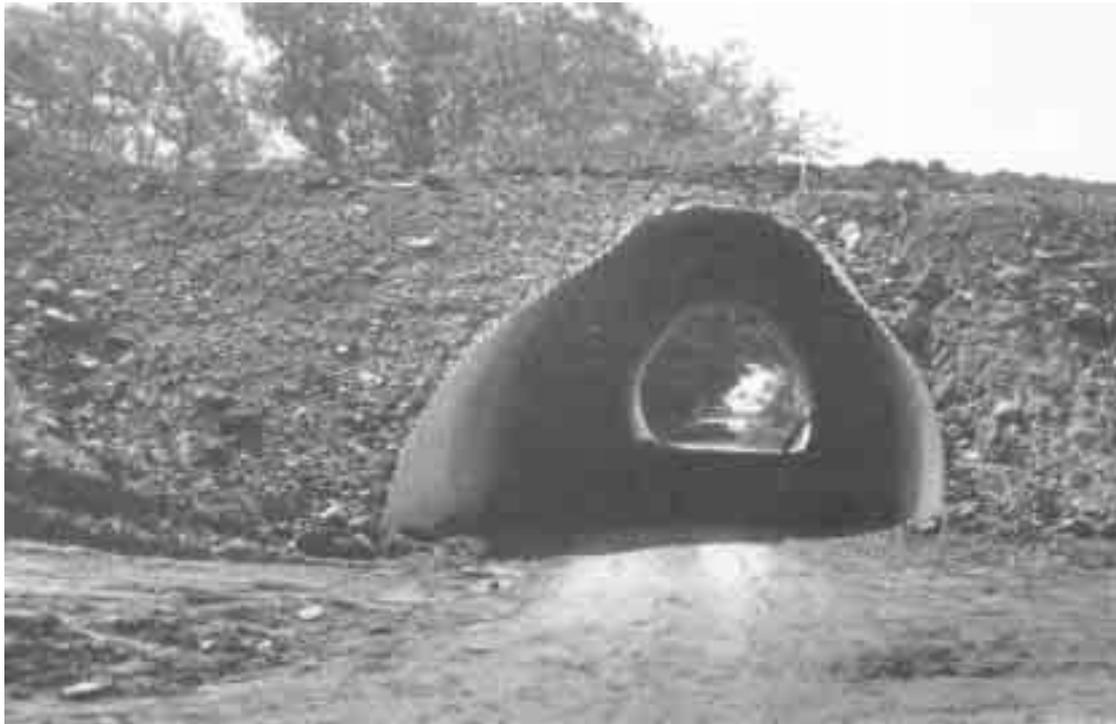
Figure 5.2a Excessive deflection of a multi-plate pipe-arch in France (from SETRA, 1992)

Figure 5.2 Excessive deflections of CSBS due to poor construction practice

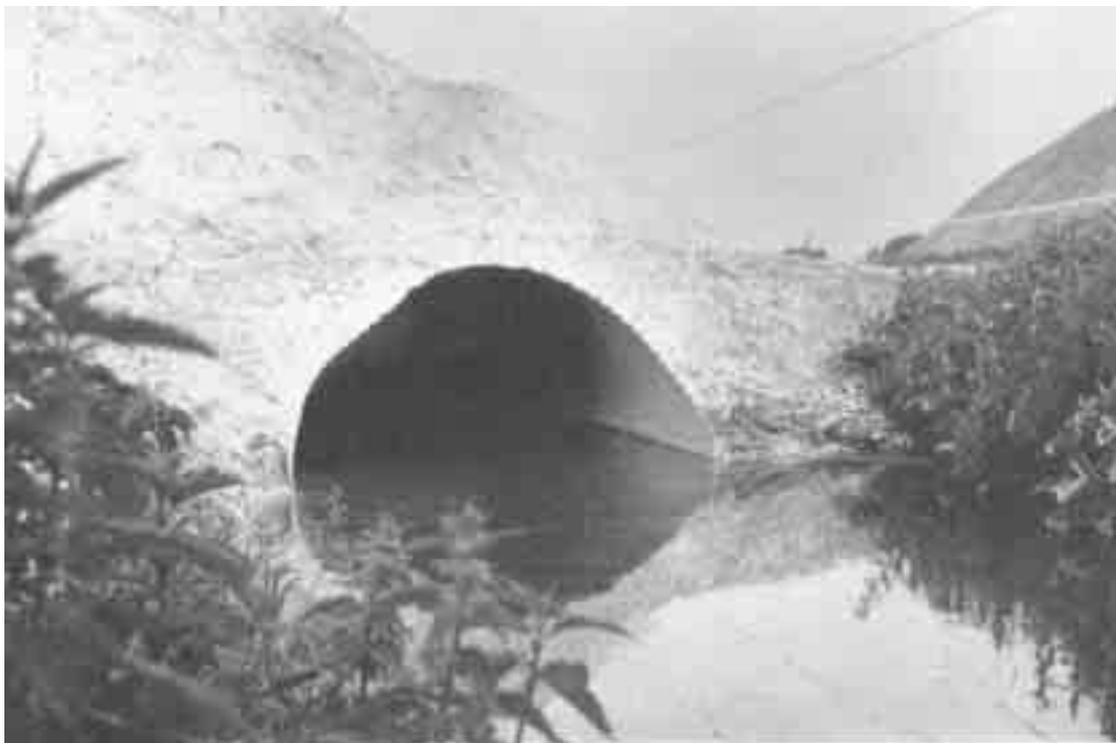
Figure 5.2b Partial collapse of a multi-plate pipe-arch in France (from SETRA, 1992)

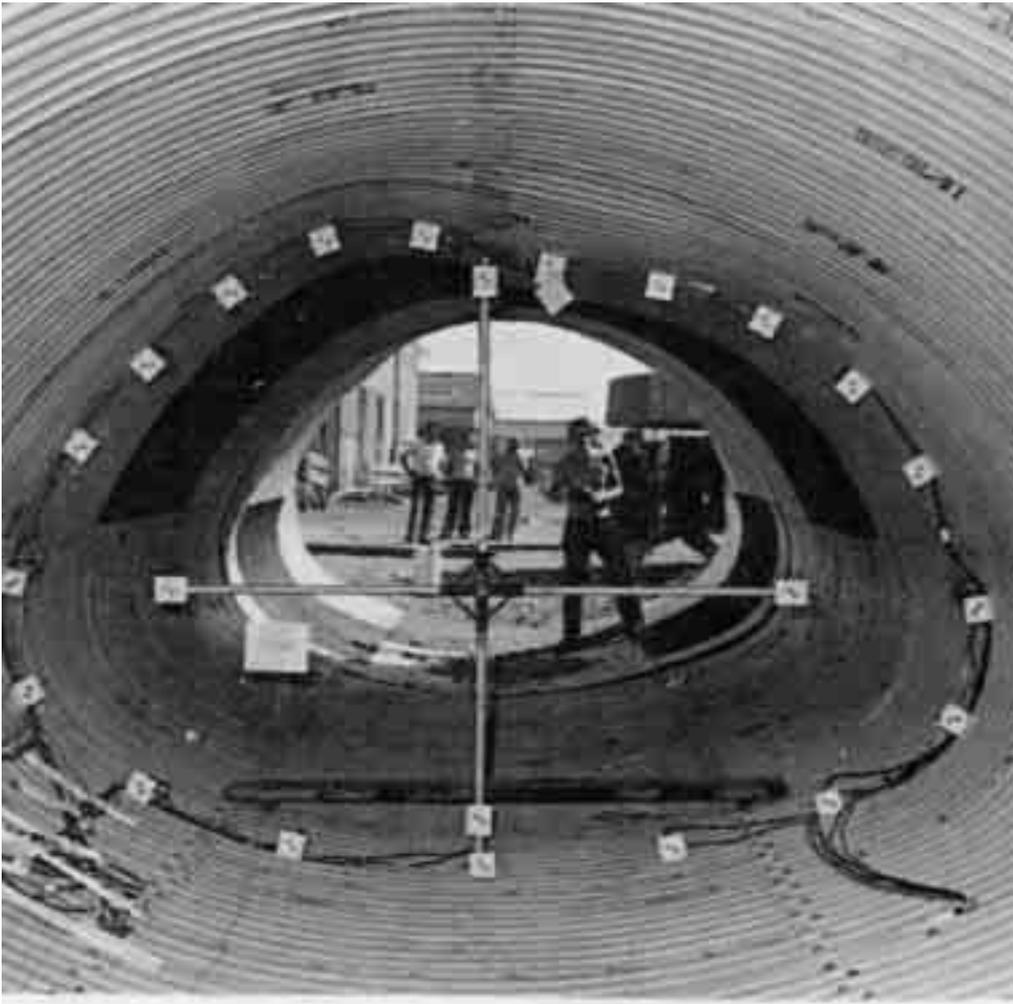
Figure 5.3 Reverse curvature - buckling due to excessive live loading at low depths of cover

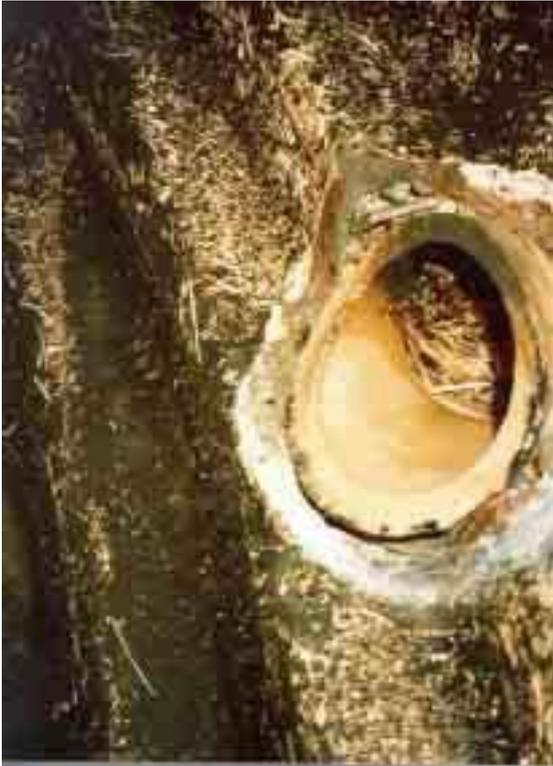
Figure 5.4a Ceramic pipe entering close to the crown

Figure 5.4 Corrosion around road drainage gulleys entering multi-plate pipe-arches

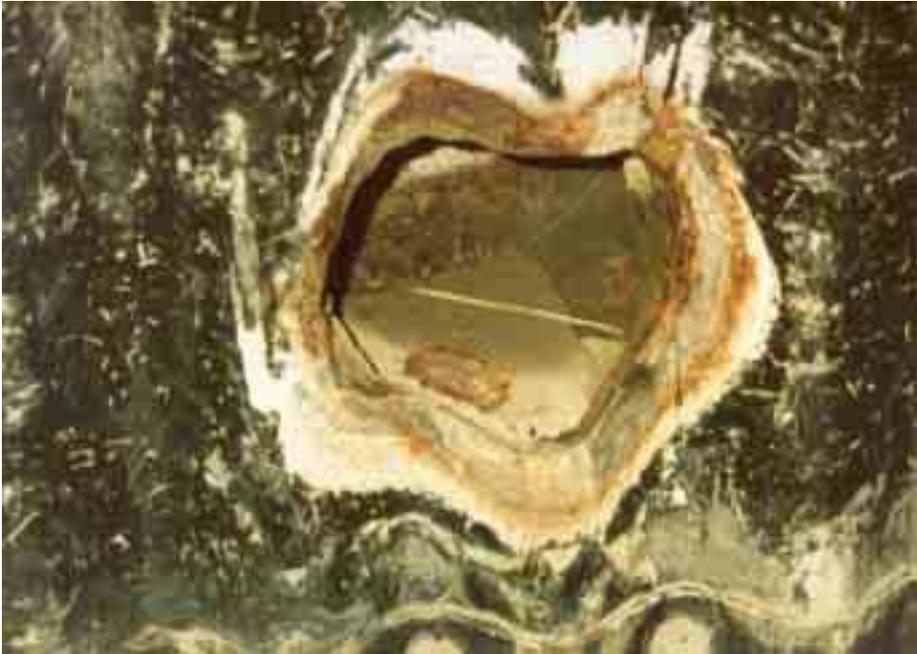
Figure 5.4b Side entry gully just above the paving

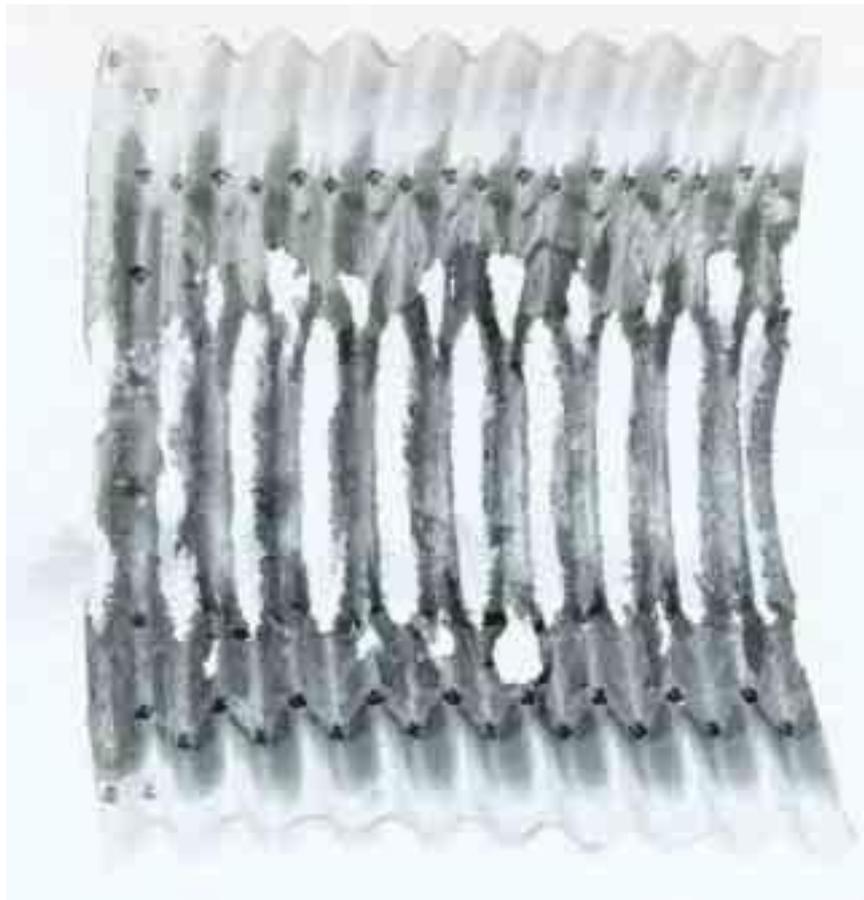
**Figure E1** Example of extreme corrosion in the invert of a structure subject to scour (this 30 year old structure was not provided with a paving or bitumen coating)

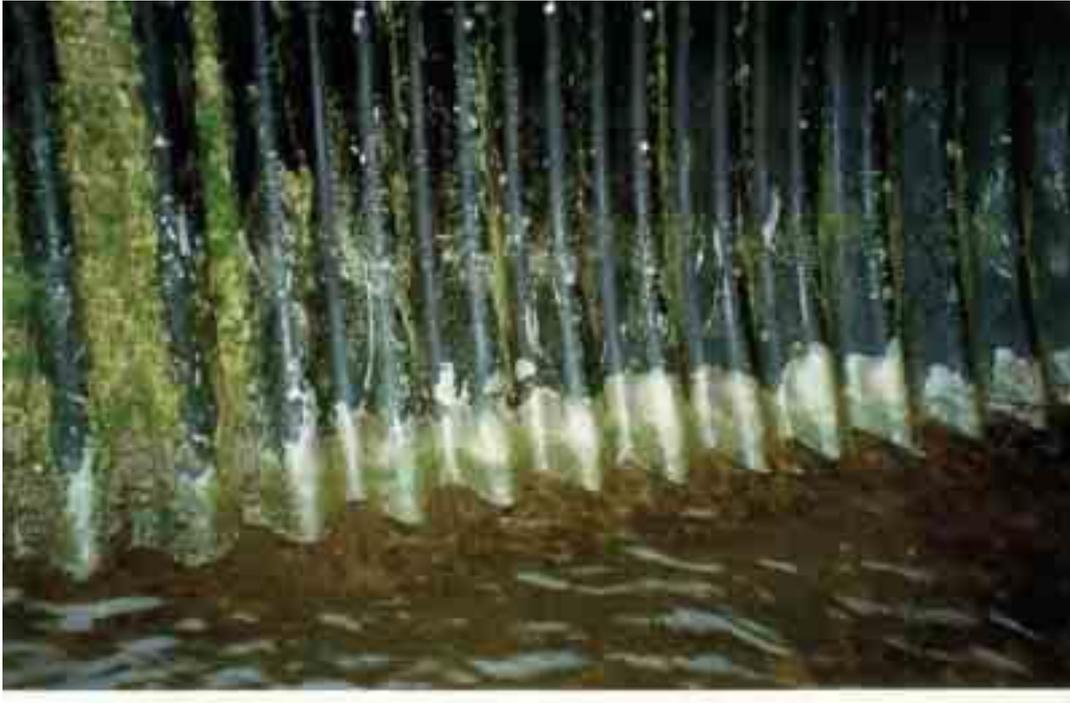
- 3.9 Fluctuating water levels generate wetting and drying cycles that might deteriorate coatings. This may be particularly noticeable in culverts carrying little or no flow - here coatings may be removed in a narrow band along the whole length of a culvert. Bitumen coatings to the AASHTO M190 Standard are susceptible to this form of deterioration.

**Figure E2a** Deterioration along the wet/dry line in low flow conditions

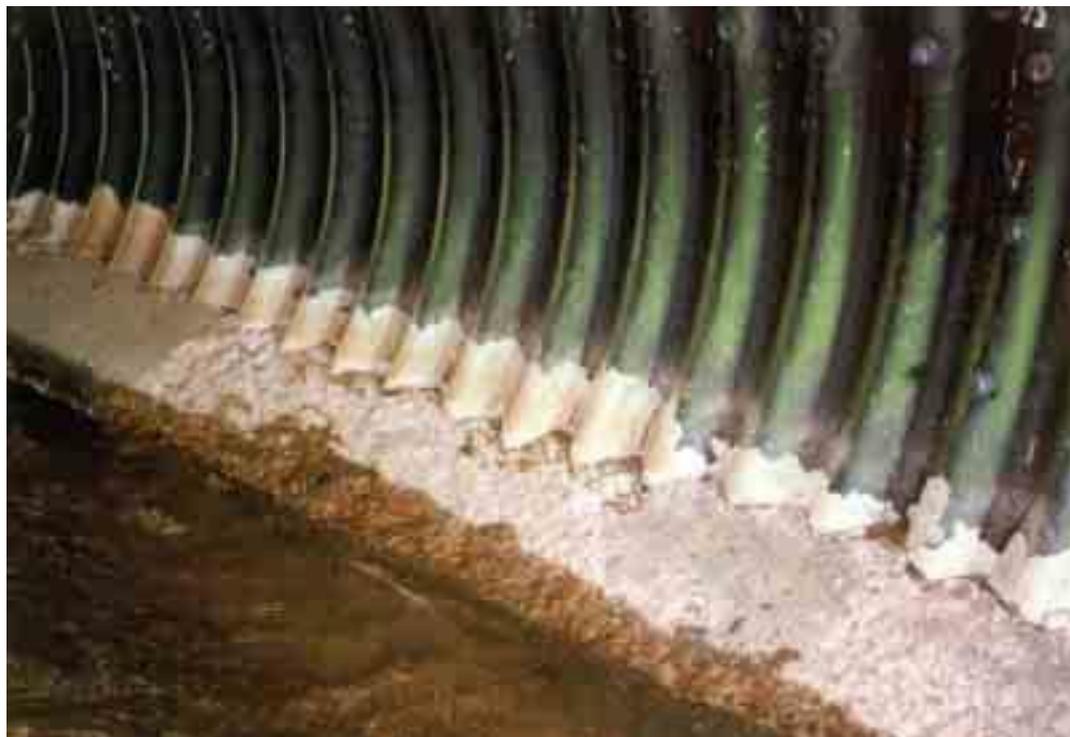
- (i) Damage to coatings above the invert paving, where the culvert size is insufficient to contain the flow. The misalignment of a culvert, with respect to the original water channel, might generate turbulence in the stream, particularly at the inlet, and lead to deposition of debris blocking the waterway leading to overtopping of the road. Overtopping might also be generated by differential settlement along the length of a structure.

**Figure E2b** Damaged caused by overtopping of paving during turbulent flow

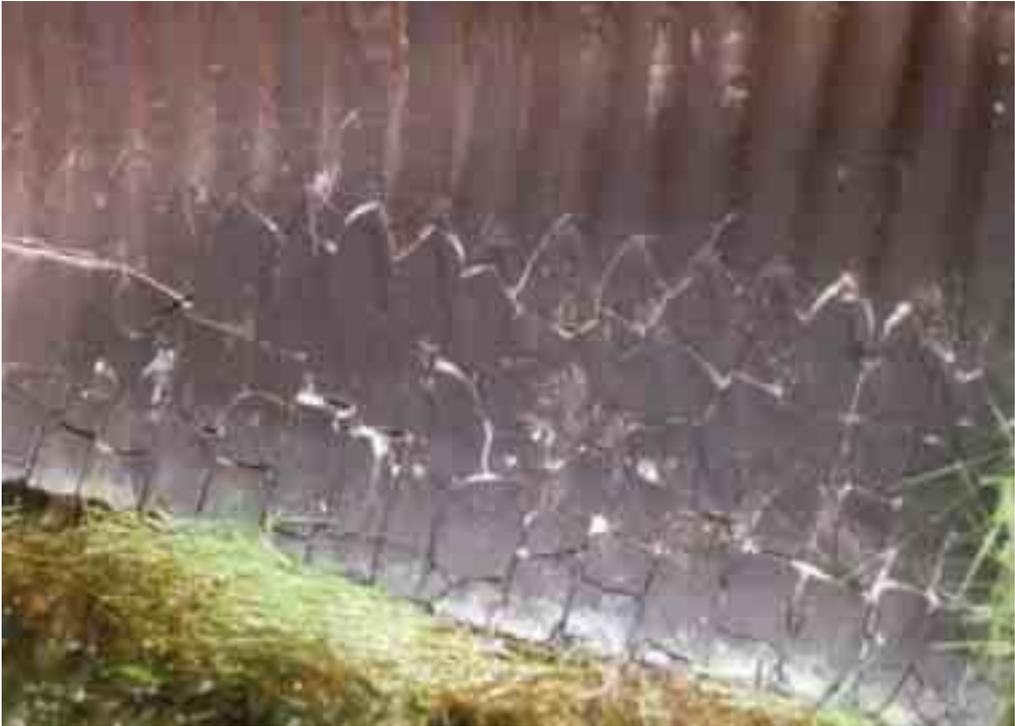
- (ii) Bitumen pavings deteriorate at the ends of a pipe, particularly at bevelled ends, where exposure to direct sunlight causes the bitumen to crack. Water flow may then break up the invert paving making the structure vulnerable to corrosion.

Figure E4 Cracking in a bitumen paving due to exposure to sunlight

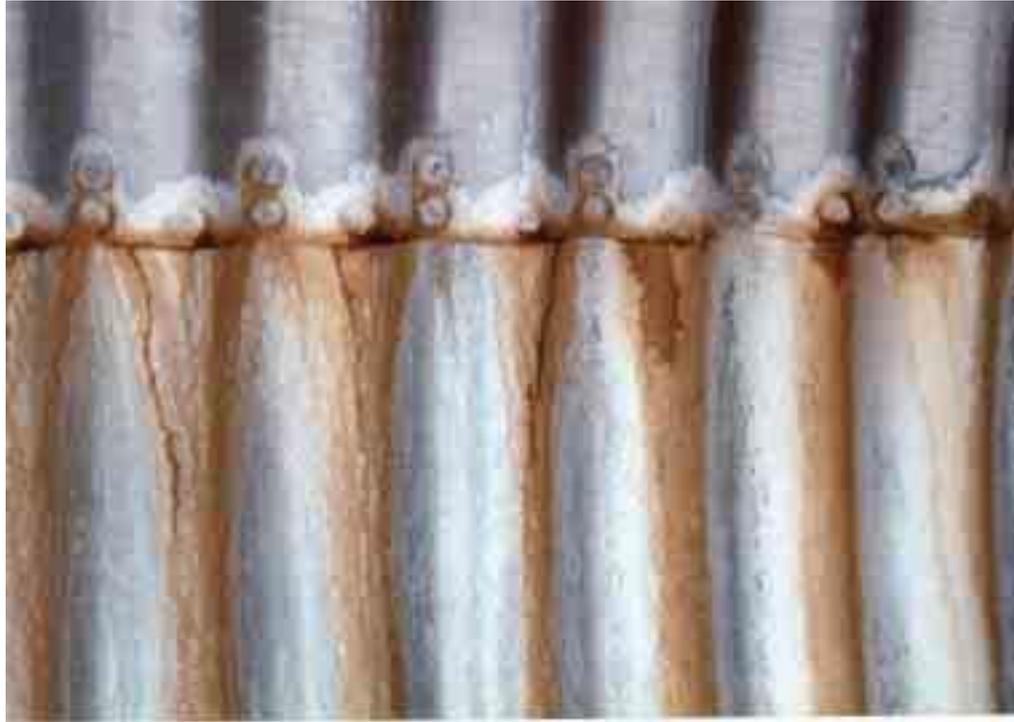
**Figure E7** Deterioration to side plates in a plain galvanised bolted segmental CSBS caused by seepage below the edge of the carriageway

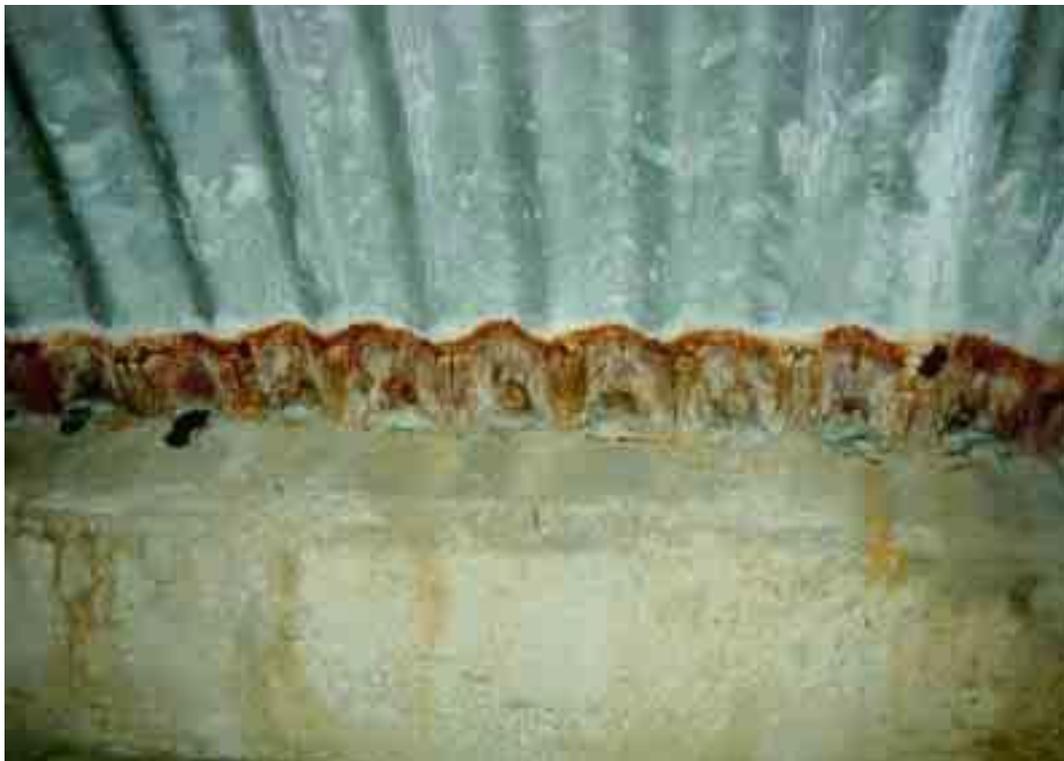
**Figure E8** Deterioration at the arch seating of a plain galvanised arch structure due to seepage and ponding of water containing de-icing salts

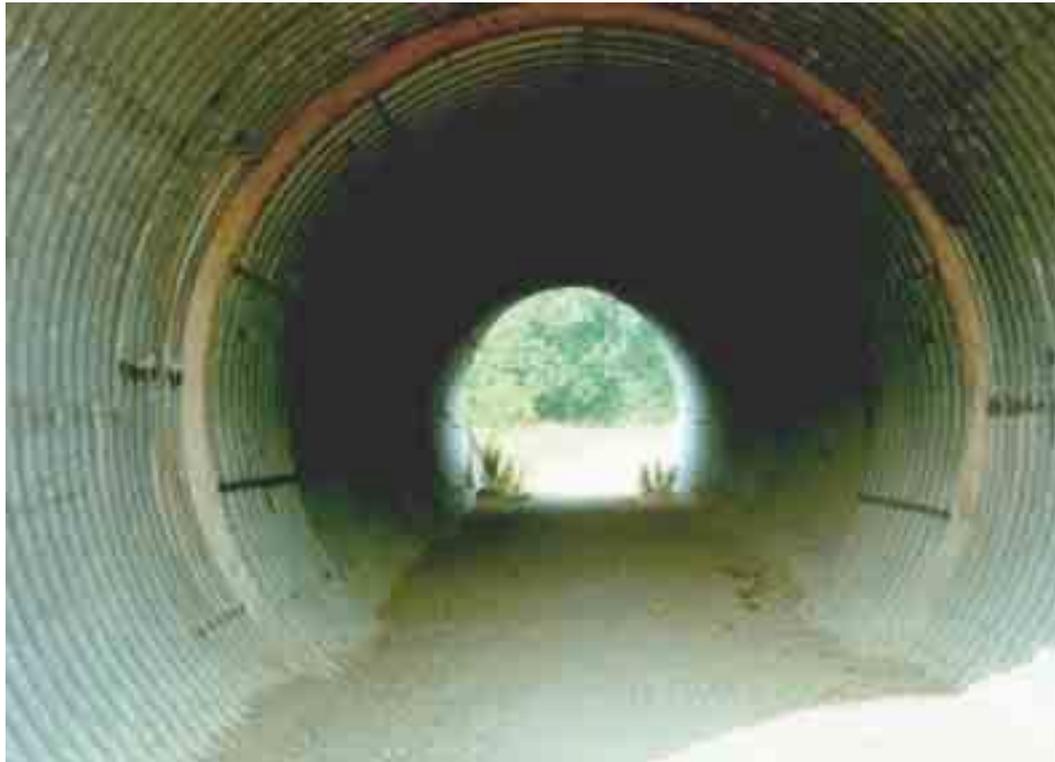
**Figure E9** Use of liner plates to repair a bolted segmental CSBS showing deterioration below the edge of the carriageway due to seepage of water containing de-icing salts
