### NRA HD 16 Temporary Safety Measures Inspections

Alastair de Beer Project Manager (Safety) National Roads Authority

National Roads Authority - Standards Section Training for New Developments April 2013

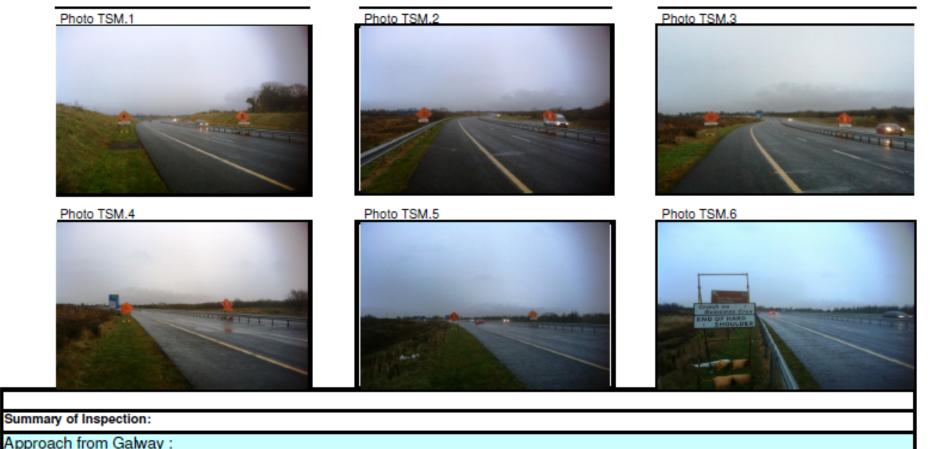
Photo TSM 1 - 1200mm 'Roadworks Ahead' signage with supplementary plate.

Photo TSM 2 - 1200mm 'Offside Lane Closed' signage with supplementary plate. TM ahead tranfers fast lane to slow lane(fast lane and hard shoulder closed) and then slow lane to fast lane (hard shoulder and slow lane closed) prior to Junction 13.

Photo TSM 3 - 1200mm 'Offside Lane Closed' signage with supplementary plate.

Photo TSM 4 - 1200mm 'Offside Lane Closed' signage with supplementary plate. Plate colour not in accordance with P001 (refer to Table 8.2.2 of Chapter 8)

Photo TSM 5 - 1200mm 'Offside Lane Closed' signage with supplementary plate.

Photo TSM 6 - 'End of Hard Shoulder' supplementary plate. Note 100m distance plate on verge.

Photo TSM 7 - Advance warning of hard shoulder closure and commencement of fast lane taper. No lamps to taper. This location is unlit. Does not comply with the recommendations of Table 8.3.5, paragraph 8.2.5.6 and paragraph 8.2.8.3 of Chapter 8.

Photo TSM 8 - Hard shoulder taper. Cones in taper appear to be approx. 3m c/c. Table 8.3.5 of Chapter 8 recommends 1.5m c/c.

Summary of lenge-clien: Approach from Cablety : Photo TSM + Lacommin Cablety : Photo TSM + Lacommin Cablety is a Closed signage with supplementary plate. TM sheed tearlies had here to slow lano(fast area and here a device of closed and them slow signage with supplementary plate. TM sheed tearlies that here to slow lano(fast Photo TSM = Lacommin Chable Lane Closed signage with supplementary plate. Photo TSM = Lacommin Chable Lane Closed signage with supplementary plate. Photo TSM = Lacommin Chable Lane Closed signage with supplementary plate. Photo TSM = Lacommin Chable Lane Closed signage with supplementary plate. Photo TSM 5 - Lacommin Chable Lane Closed signage with supplementary plate. Photo TSM 5 - Lacommin Chable Lane Closed signage with supplementary plate. Photo TSM 5 - Lacommin Chable Lane Closed signage with supplementary plate. Photo TSM 5 - Lacommin Chable Lane Closed signage with supplementary plate. Photo TSM 5 - Lacommin Chable Lane Closed signage with supplementary plate. Photo TSM 5 - Lacommin Chable Lane Closed signage with supplementary plate. Photo TSM 5 - Lacommin Chable Lane Closed signage with supplementary plate. Photo TSM 6 - Lacommin Chable Lane Closed signage with supplementary plate. Photo TSM 6 - Lacommin Chable Lane Closed signage with supplementary plate. Photo TSM 6 - Lacommin Chable Lane Closed signage with supplementary plate. Photo TSM 6 - Hard shoulder typer. Cores in type appear to be approx. an of c. Table 6.3.5 of Chapter a recommends 1.5m ofc.

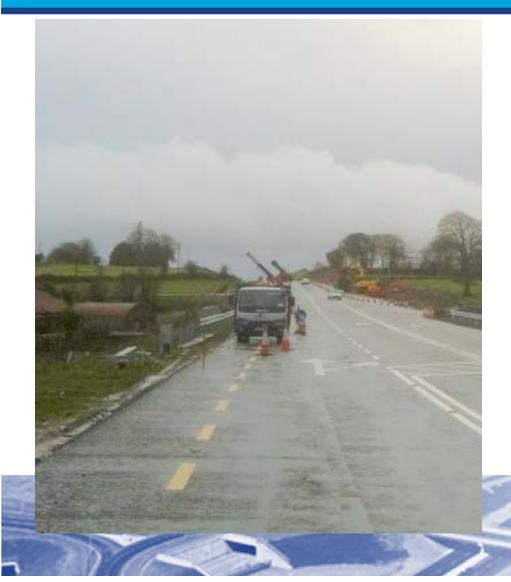
•No Reflective markings or signage on truck

- Insufficient cones
- •No Safe Zone
- •No pre-warning

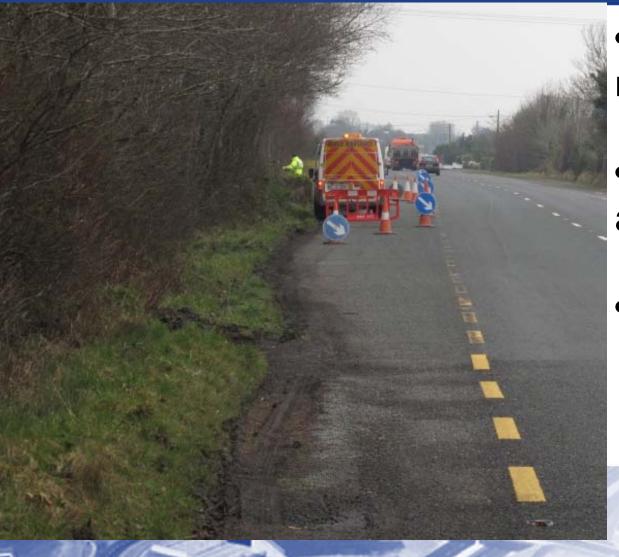
•Good Reflective markings on vehicle

•Cones well defined and deliniated

•Safe Zone

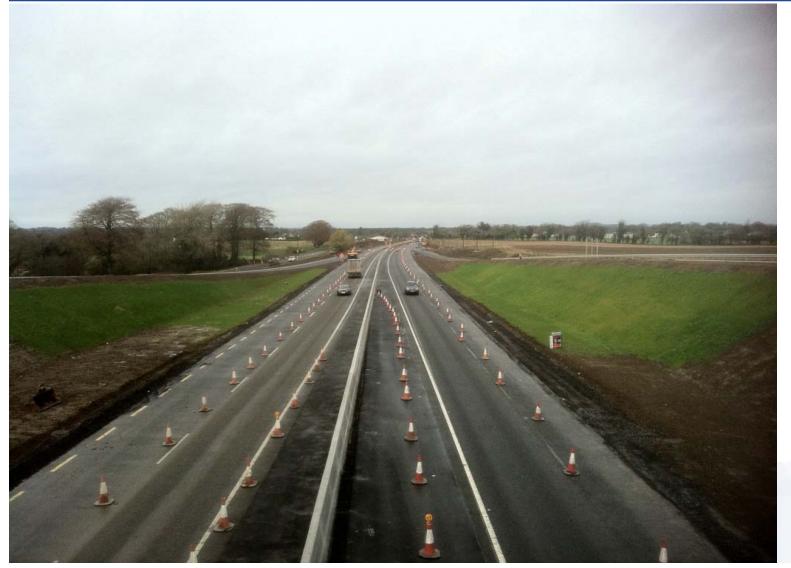
•Clear layout

•Reflectors on cones

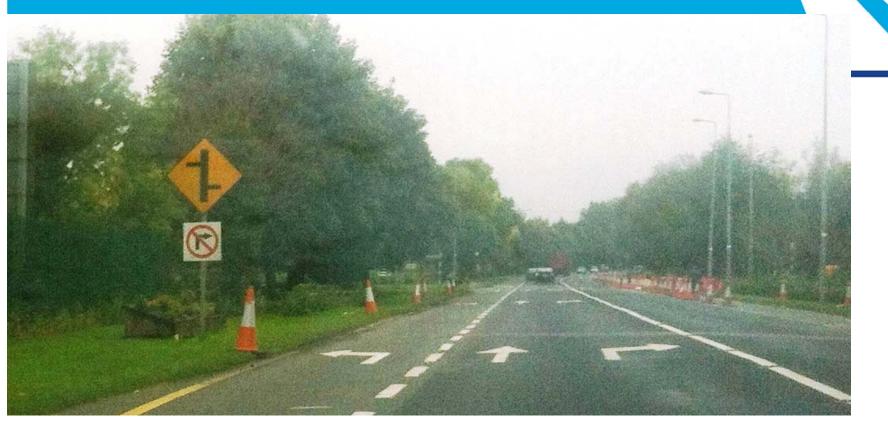
Conflicting signage
No Alternative Route indicated
Sign on non-reflective board

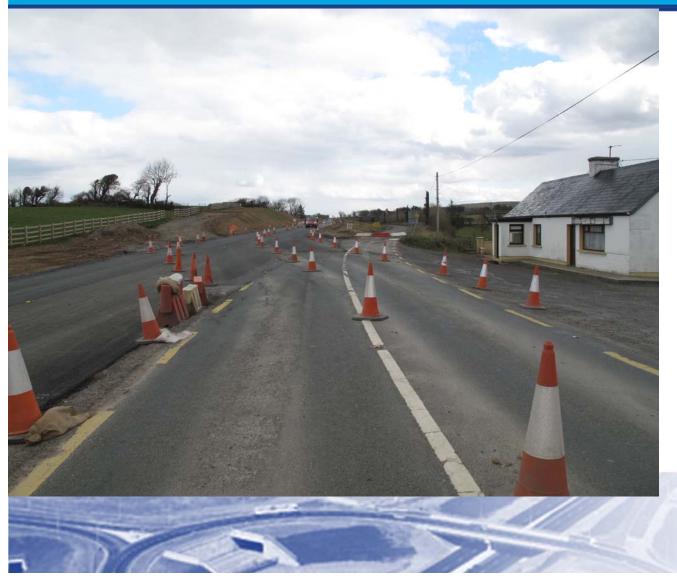
### •Old lining not removed

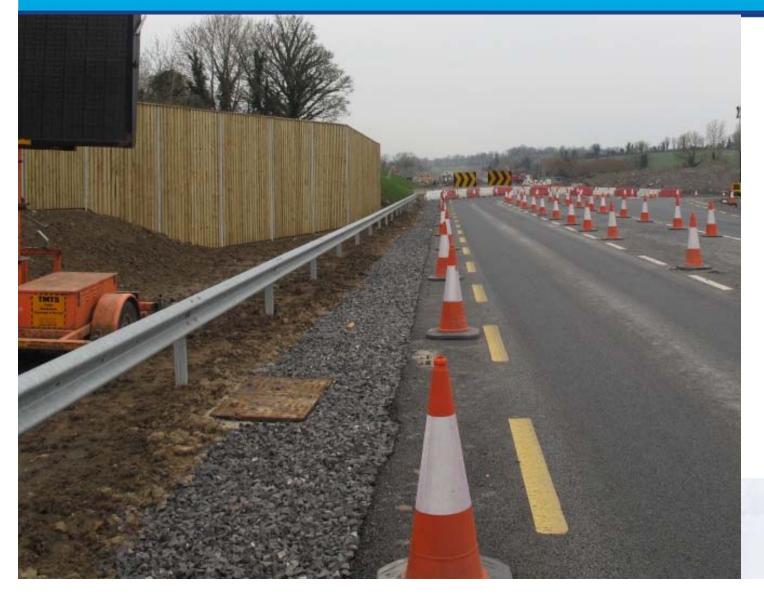
How it should be done!!

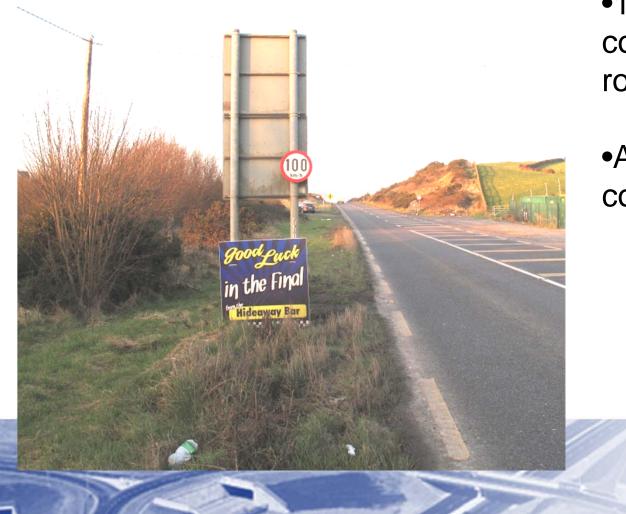
•100km/h sign not covered in middle of roadwork's

•Advertisement within confines of roadworks

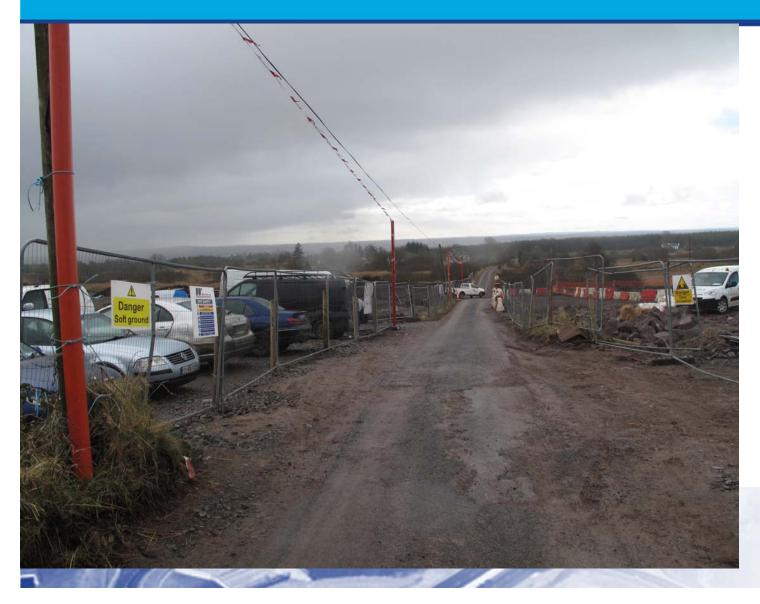
Fenced parking area created for operatives. Side road left clear from parked vehicles. Common hazard removed.
