Effective Bridge Management

Area Engineers March 2014

Liam Duffy - National Roads Authority

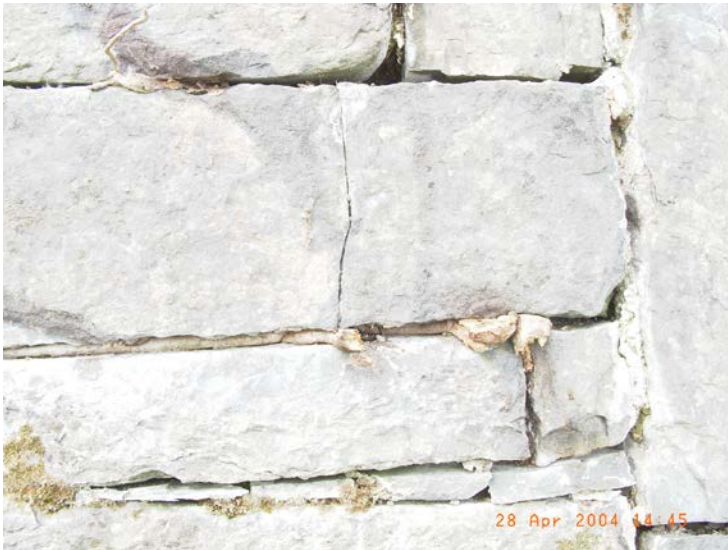
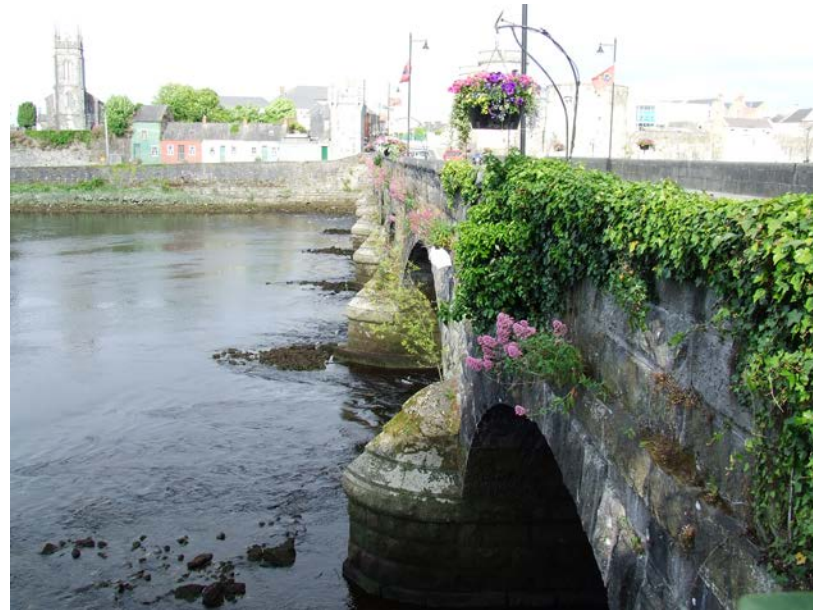
Routine inspection and maintenance

Vegetation clearance prevents stonework deterioration,
debris clearance from watercourses prevents scour damage

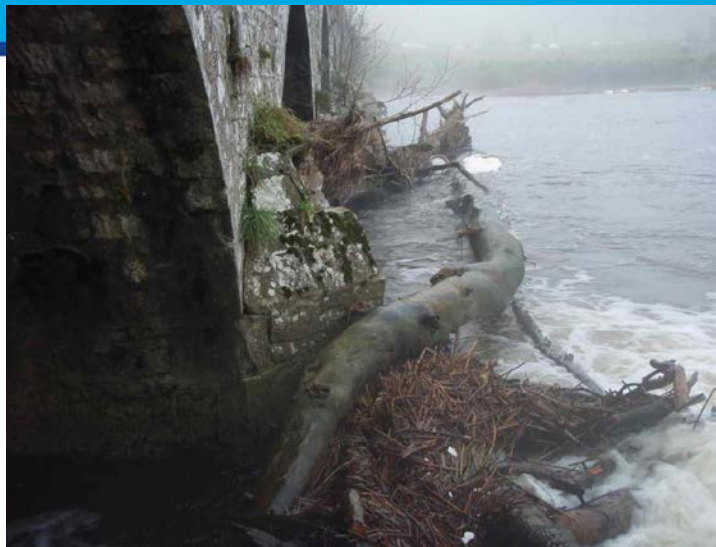
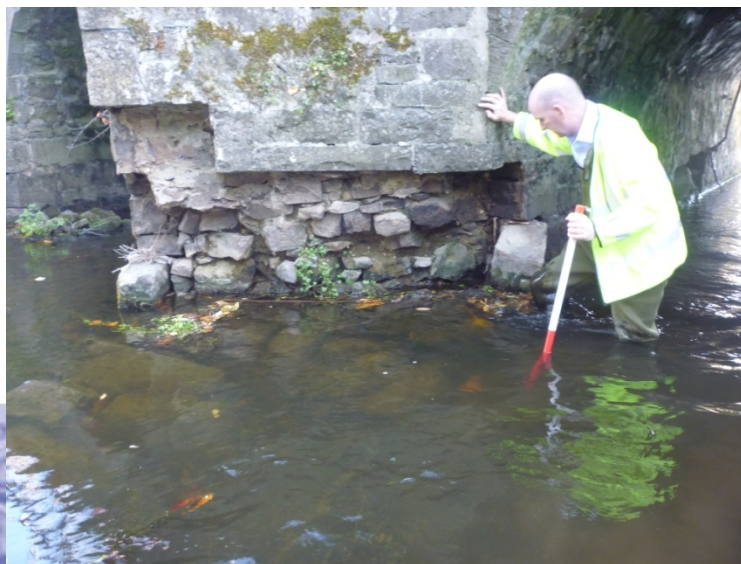
Scour Damage & Scour Susceptibility

- Debris build-up must be cleared when found
- BD97/12 Assessment of scour at highway bridges
- CIRIA C551 Manual on scour at bridges and other hydraulic structures

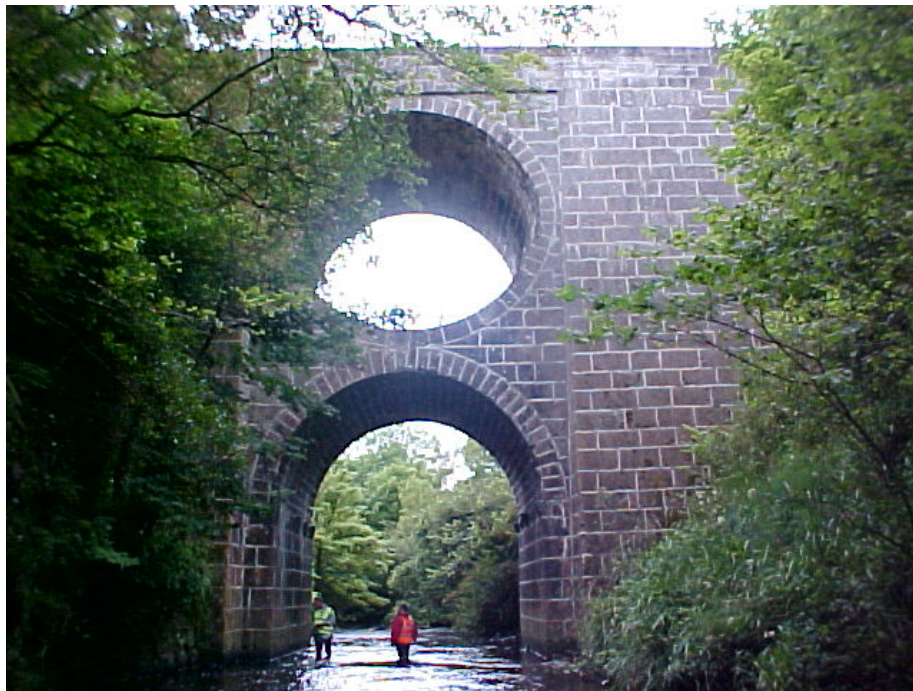
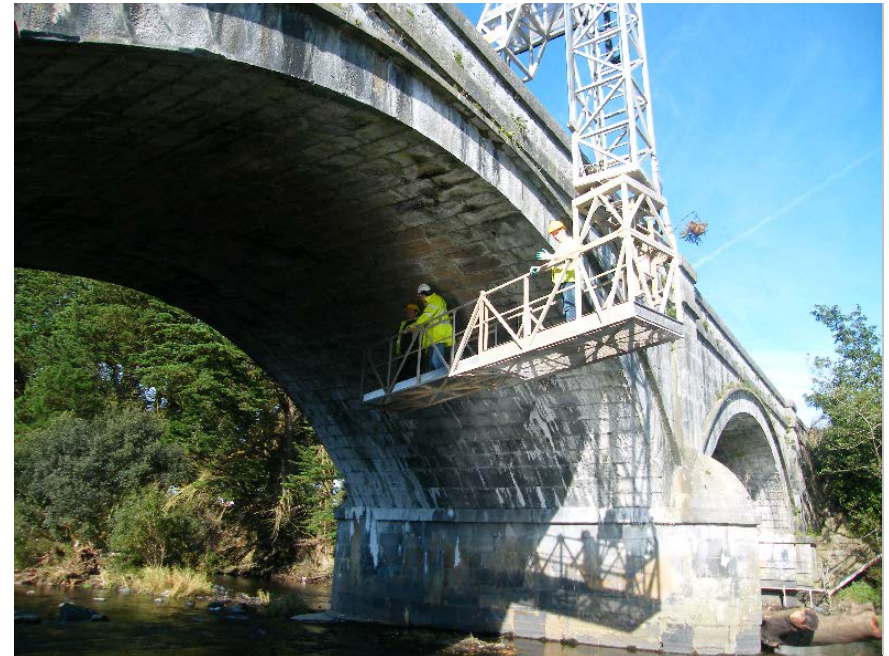
PI – Inspect difficult access components

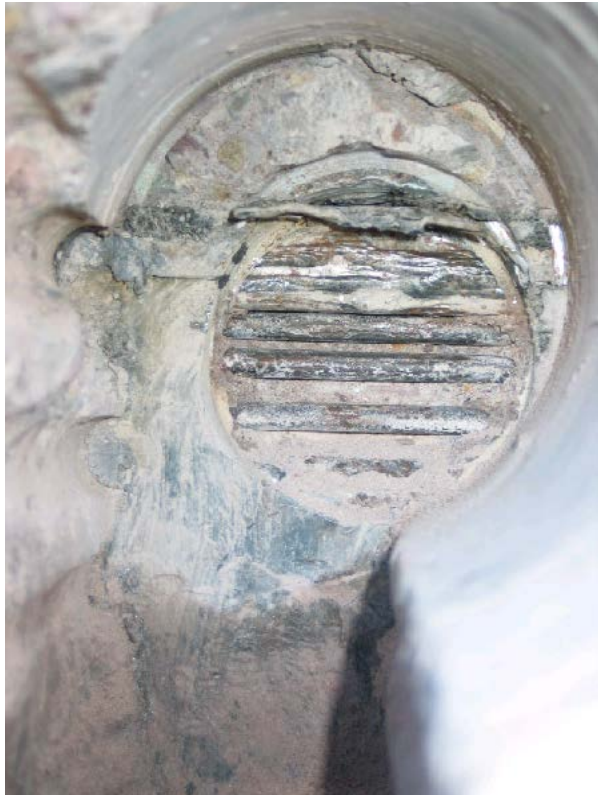
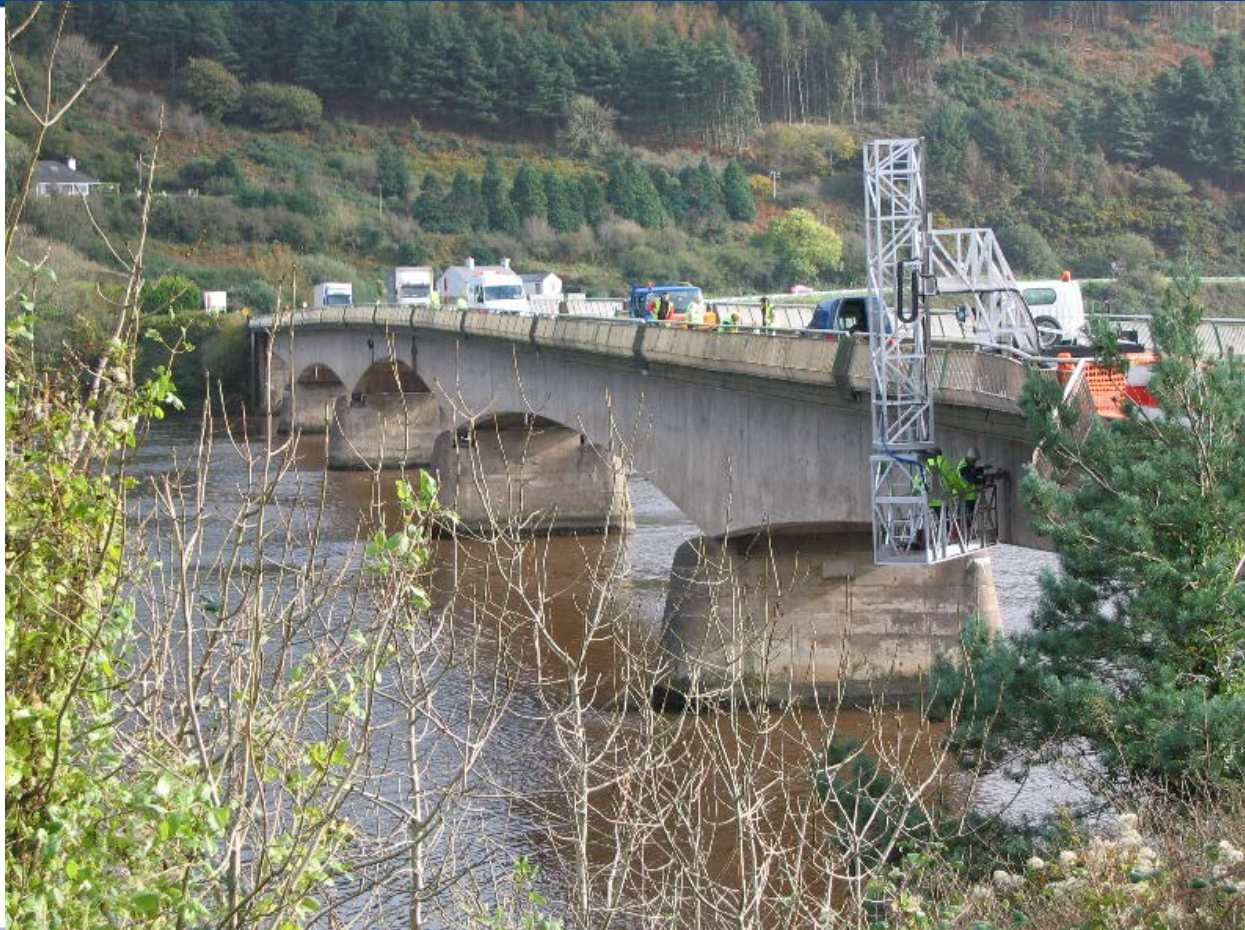
Special Inspection - Youghal Bridge

PTSI Phase 3 Inspection

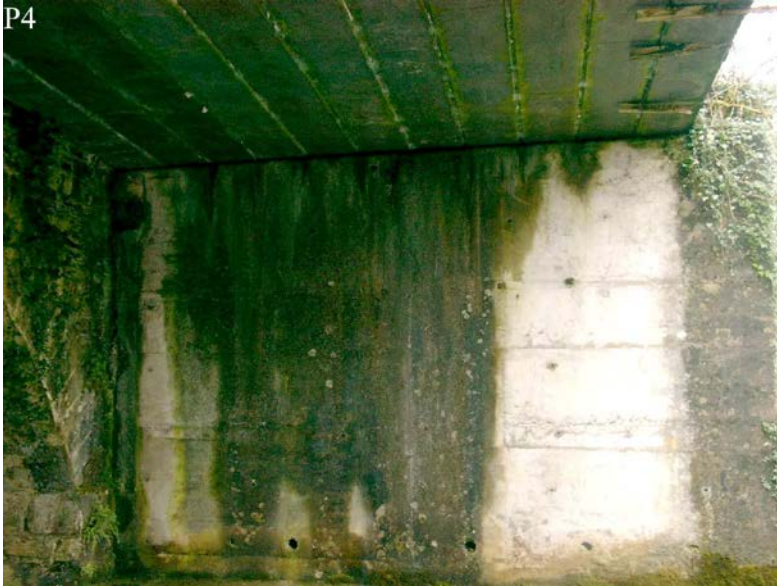
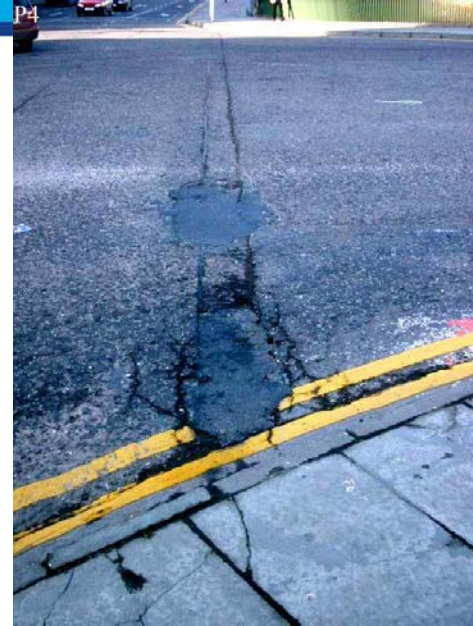
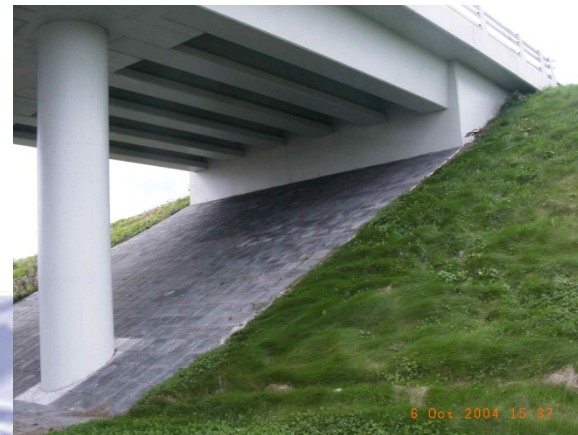
Factors affecting durability

Leaking expansion joint or failed waterproofing. Modern construction of integral bridges where possible.

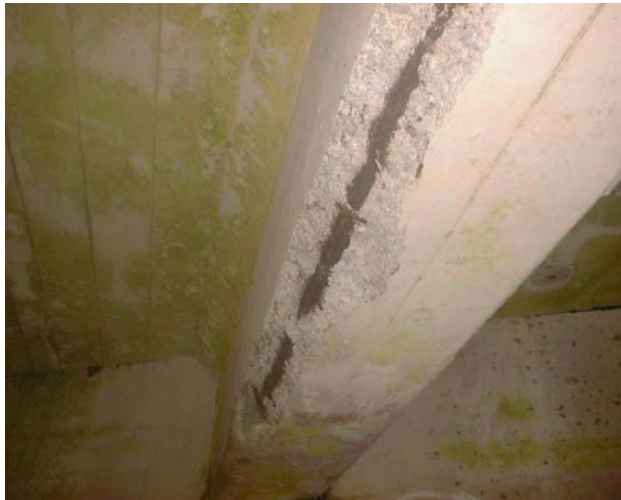
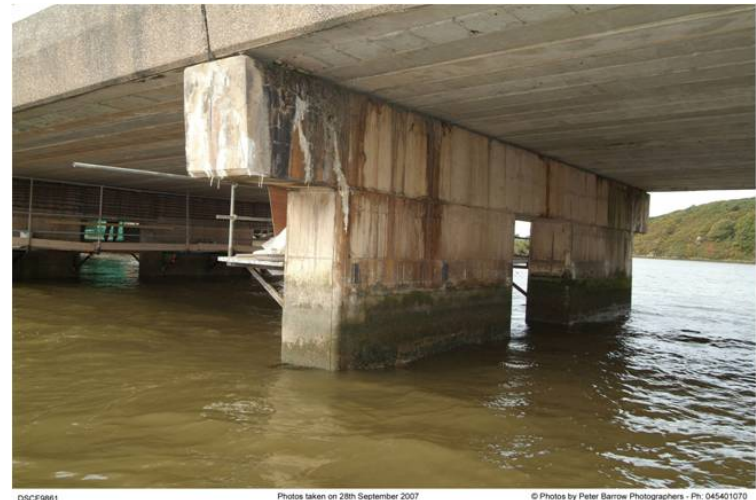
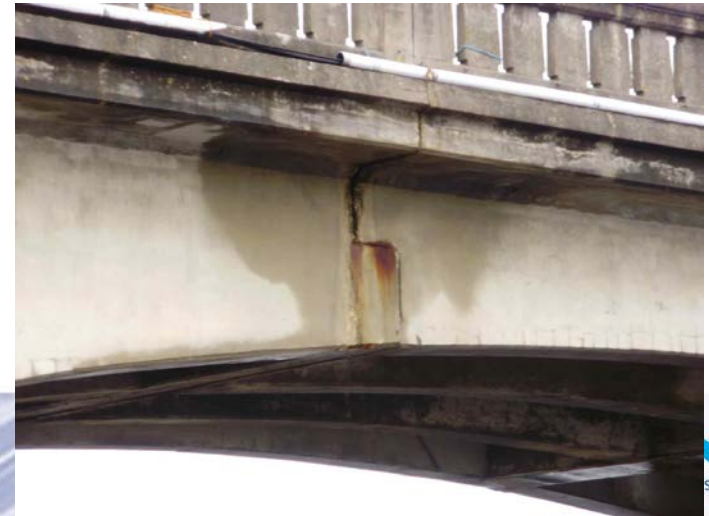
Bridge Inspector Decisions – RC Defects

- BA 35/90 Inspection and repair of concrete highway structures
- CBDG Technical Guide 2: Testing & monitoring the durability of concrete structures

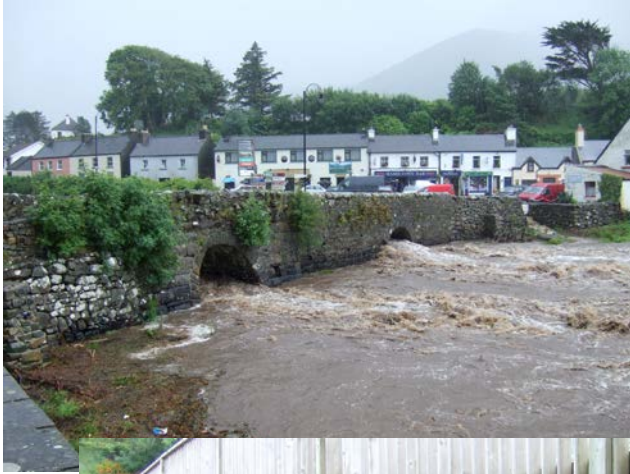
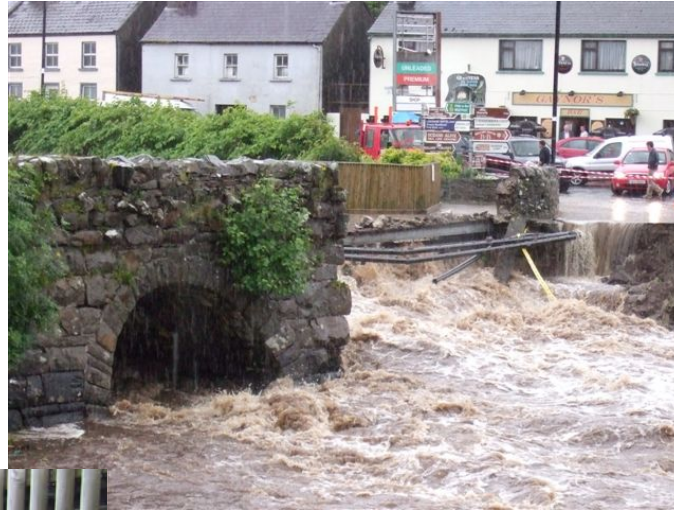
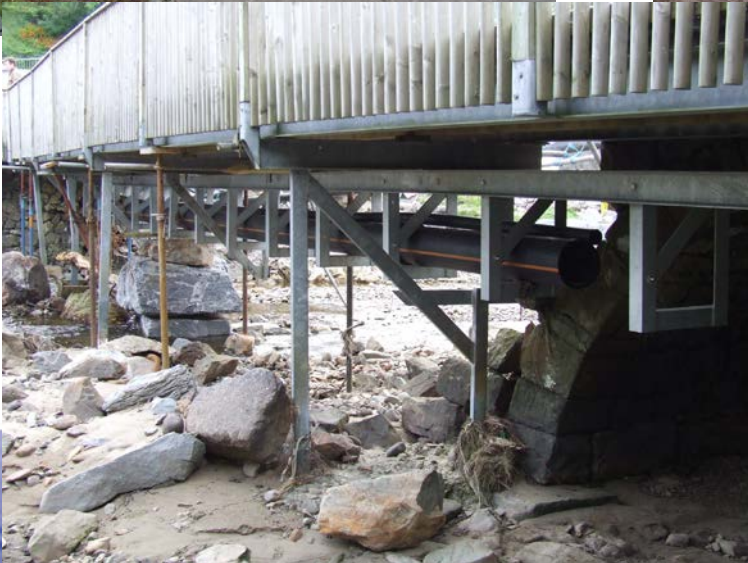
Leenane Bridge collapse

Build-up of debris at bridge following rainfall which exceeded 1/100yr return

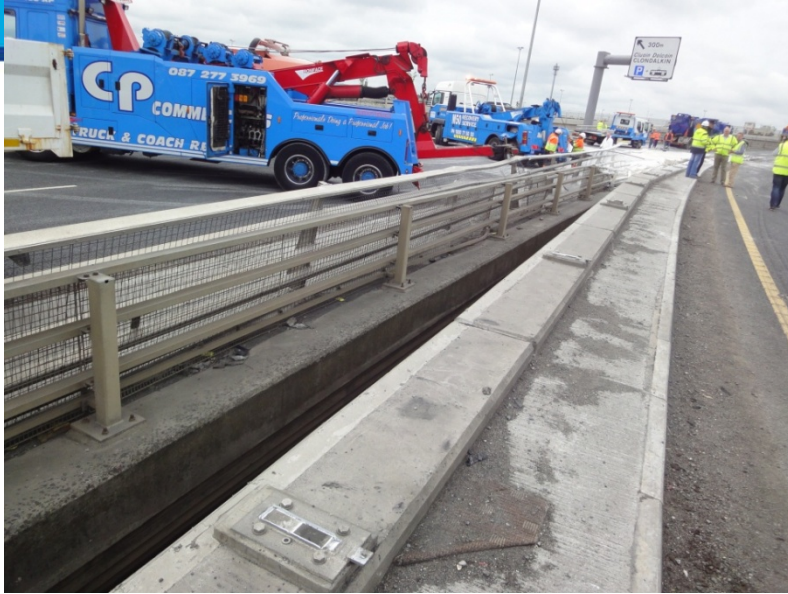
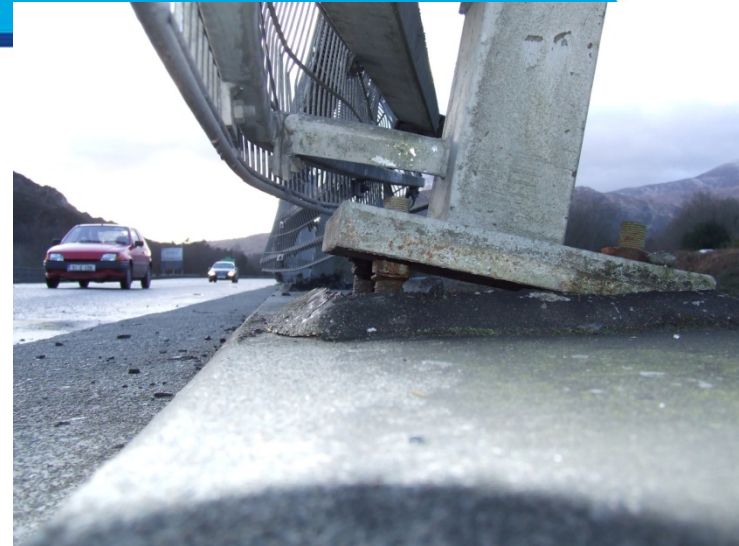
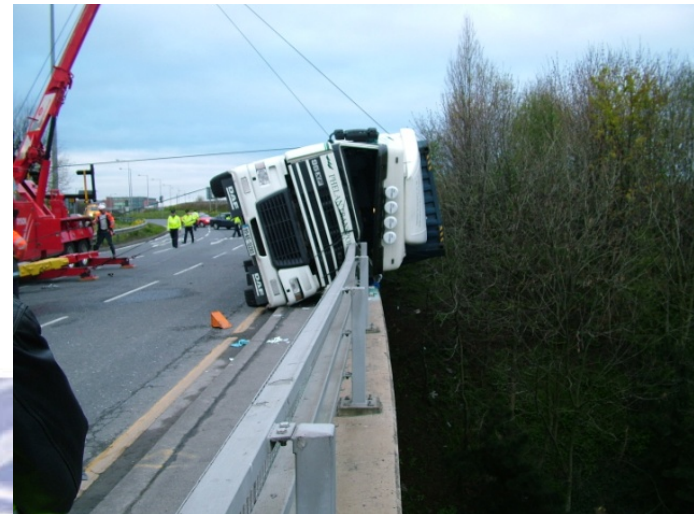
Bridge Inspector Decisions – Parapet Damage

Is the failure mode of these parapets correct?
Inspector to check for cracked posts

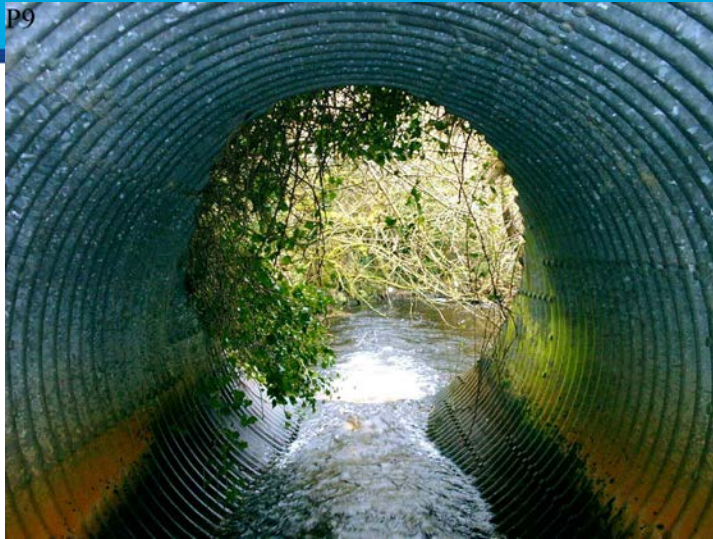
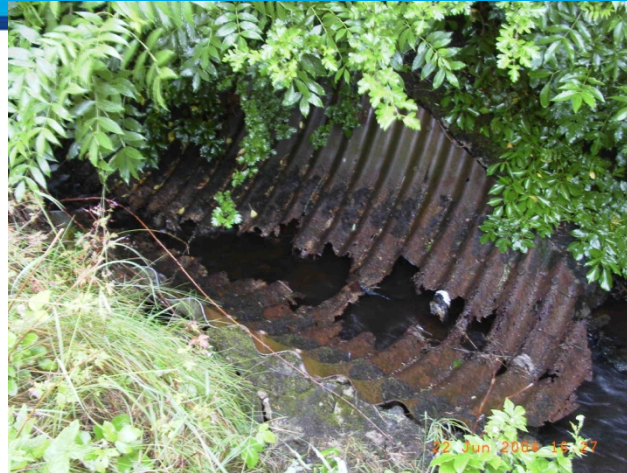
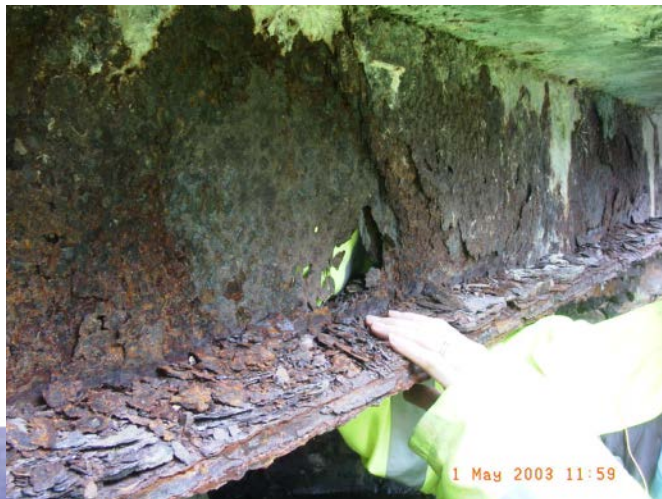
Bridge Inspector Decisions –Steel Defects

BD12 includes for concrete invert to prevent such corrosion.

Plate Girder corrosion

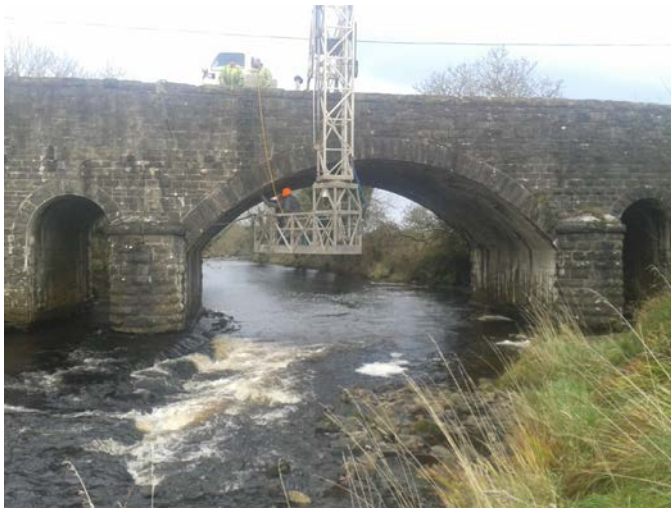
Assessments

Coring to determine arch barrel depth

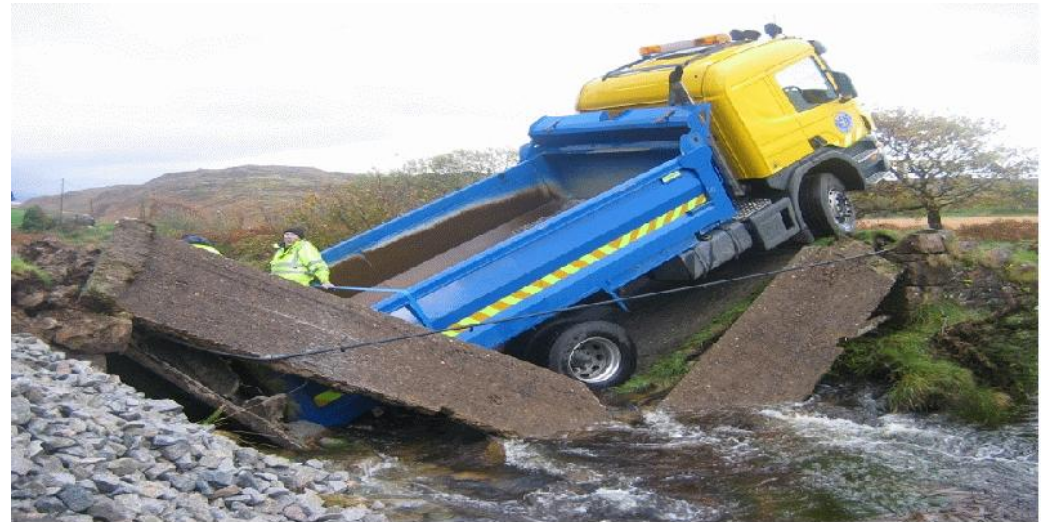
Rare example of failure under load

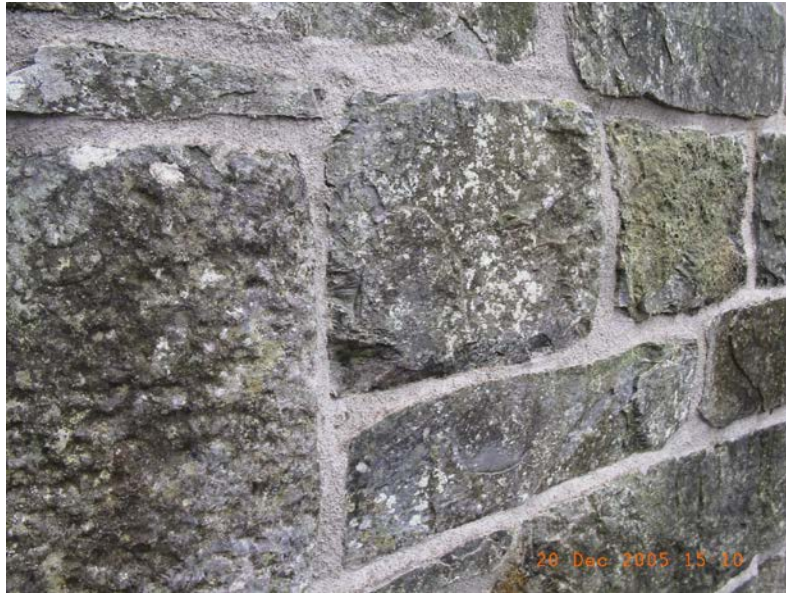
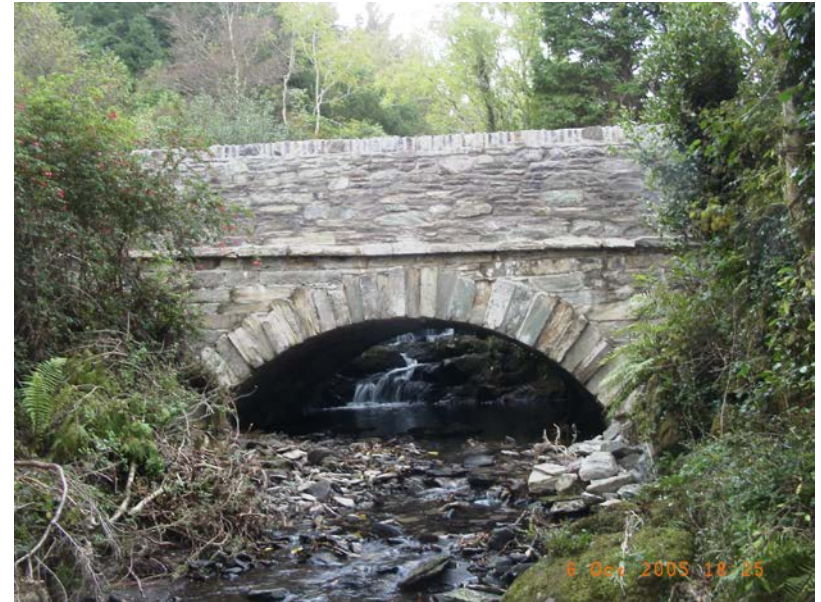
Repair historic structures sympathetically

New NRA Specification Series 2400. Lime mortar 1part NHL5 to 2.5 parts well-graded sand, full joints, stonework to match existing

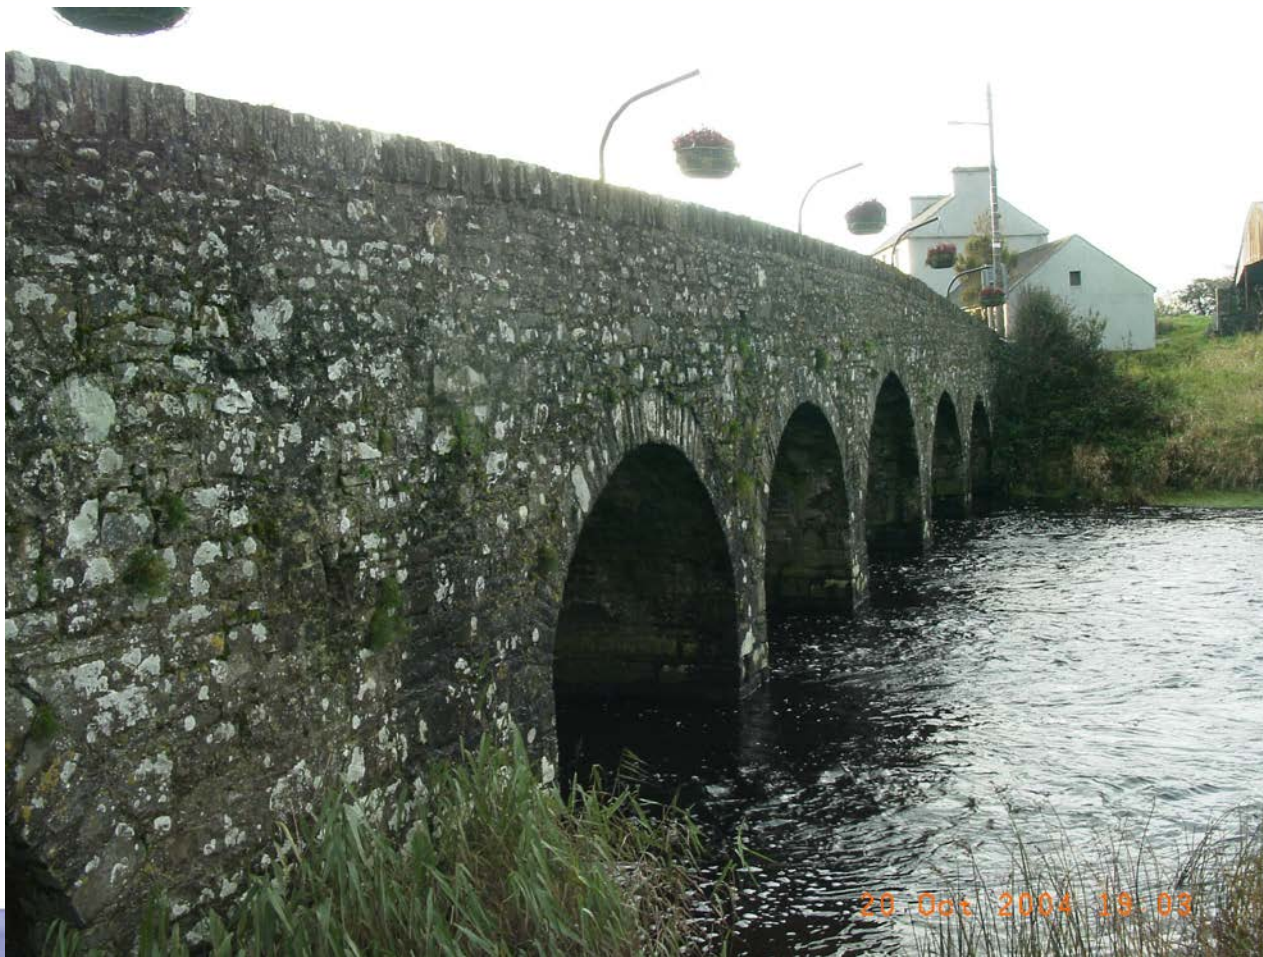
Bridge Management Issue - Services

Poor Aesthetics, Durability Issues

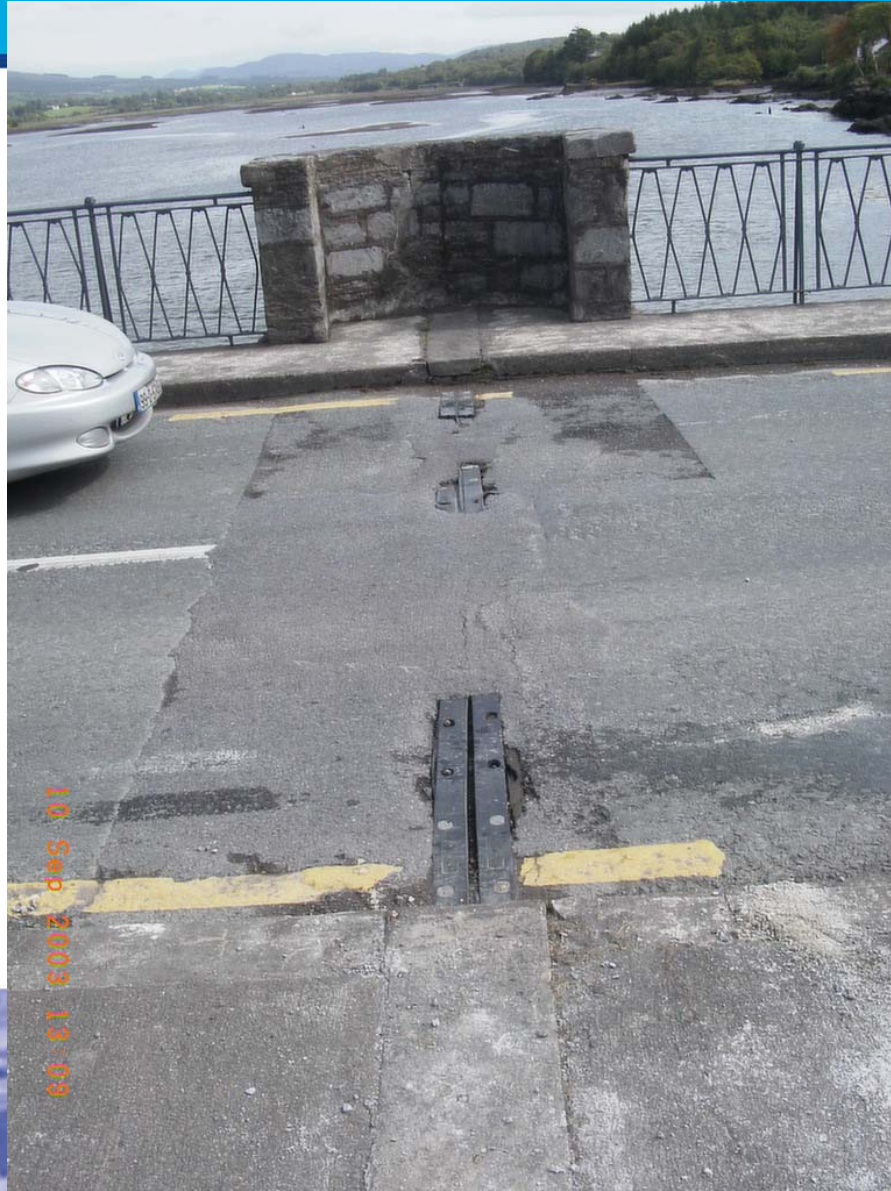
Expansion Joint Awareness

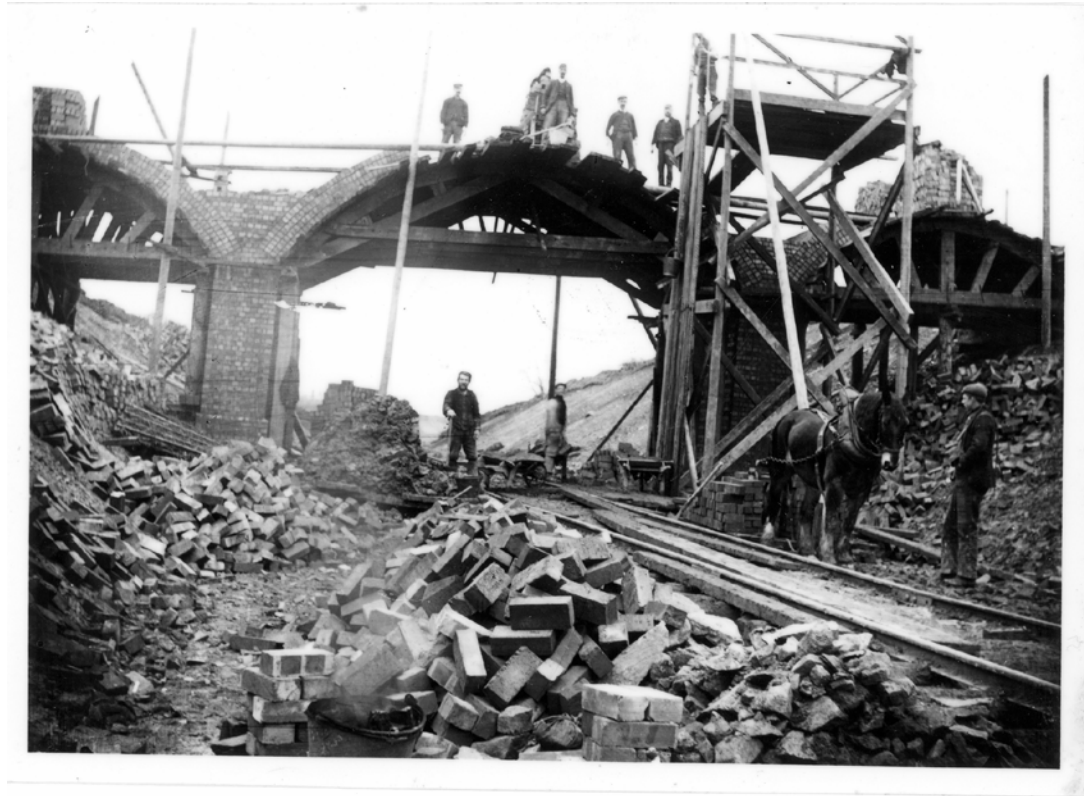
Masonry arch construction
