MASONRY WALL DETAIL

TII PUBLICATION NUMBER: CC-SCD-02407

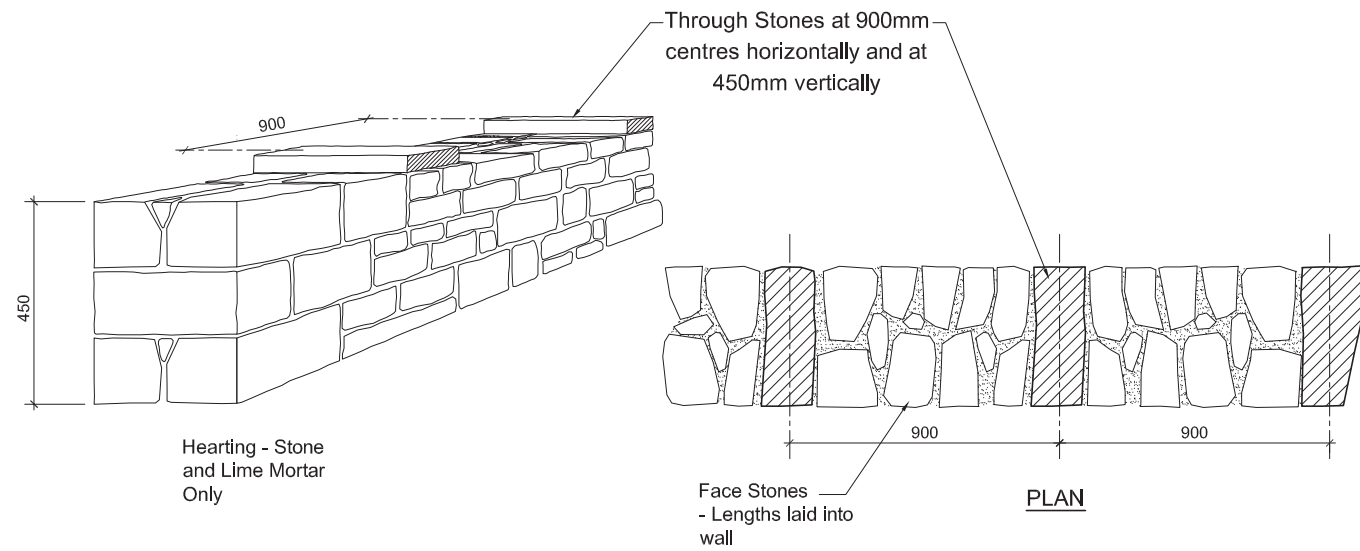
PLAN

ELEVATION

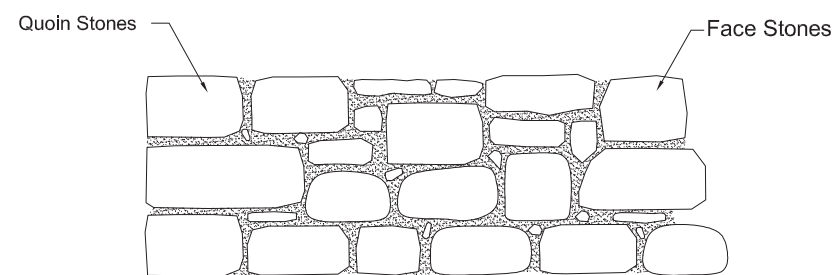
ELEVATION

Rubble Stone - Irregular shapes and sizes of stone with Sneck and Pinnings

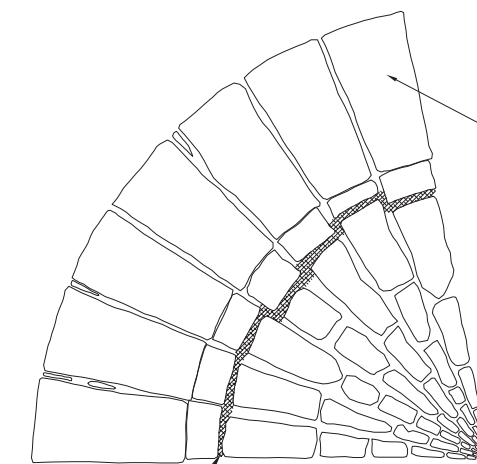
Face Voussoirs Laid Wrong - Insufficient penetration of Arch Barrel

Running Collar Joint
